Re: December 2012 Monthly Progress Report  
Administrative Settlement Agreement and Order on Consent for Removal Action  
U.S. EPA Region 10 Docket No. CERCLA 10-2009-0255  
Gasco Sediments Site within the Portland Harbor Superfund Site

## Visual Observations Log Form

**Monitoring Period:** Monthly (Year 6)—December 2012

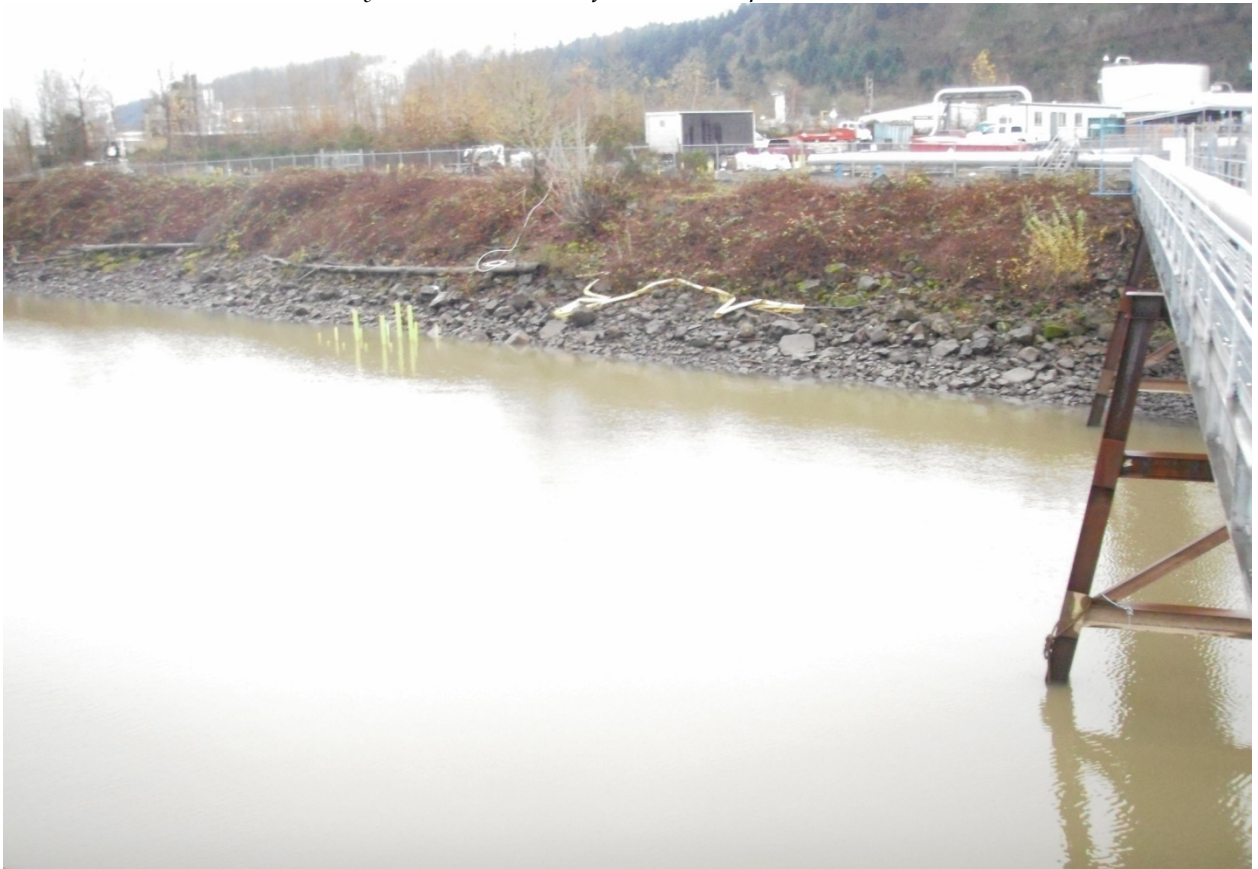
**Observations of Erosion/Deposition:** No erosion/deposition is evident along the shoreline. The shoreward extent of the cap was not visible due to high river water elevation; and the extents of the previously exposed organoclay mat material were also submerged (Photo 1).

Photo 1 — *River level currently above the extent of sediment cap (12/26/12):*

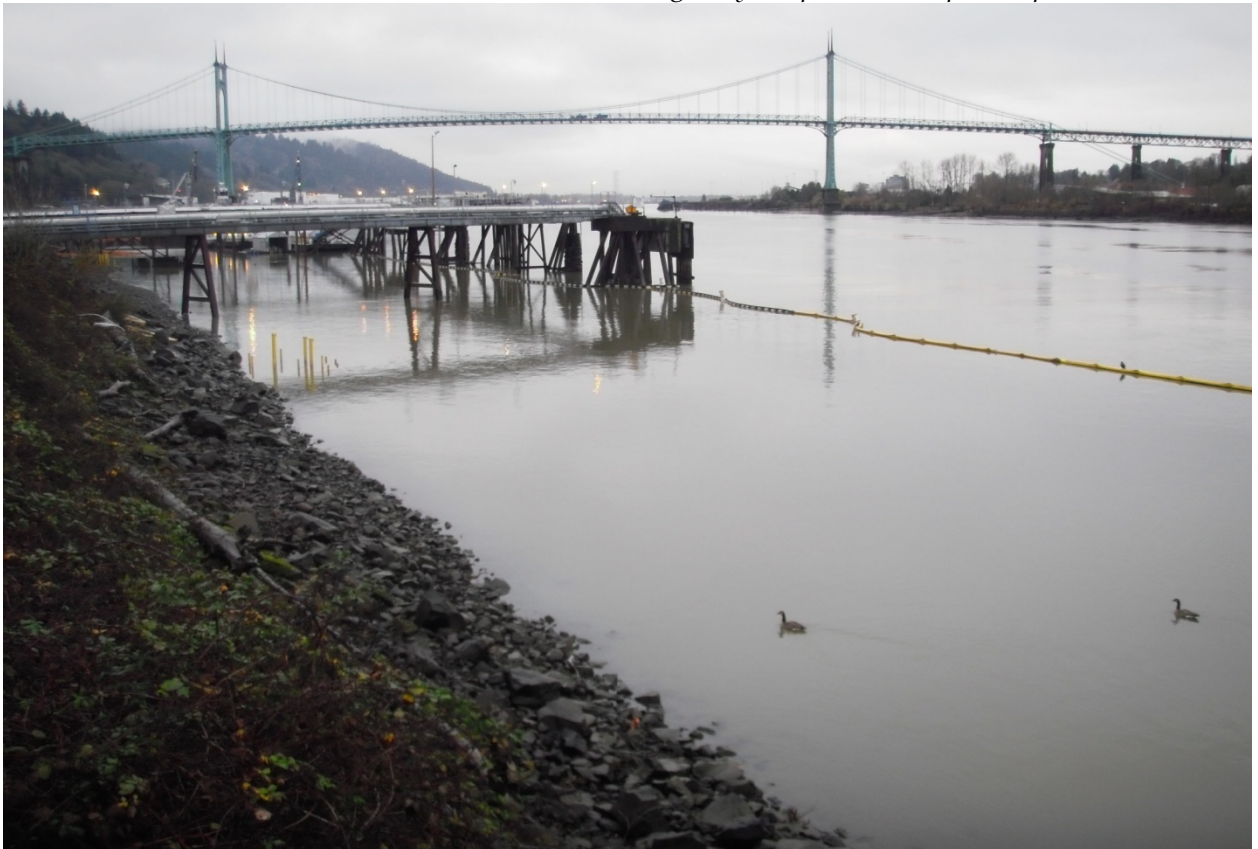
**Observations of Long-term Controls (i.e., oil booms, organo-clay mat, etc.)** During the observation, the Fuel and Marine Marketing (FAMM) containment boom was placed across the cap area, between the upriver corner of the ship dock and the wooden dolphin (near the upriver extent of the site and near the Siltronic Corporation outfall). Buoys that identify the cap area to mariners are in place as installed. The position of the FAMM oil boom, warning buoys, and a general overview of the site shoreline is shown in Photo 2.

Photo 2 — *FAMM oil boom shown and mariner warning buoys in place across pilot cap area. 12/26/12):*

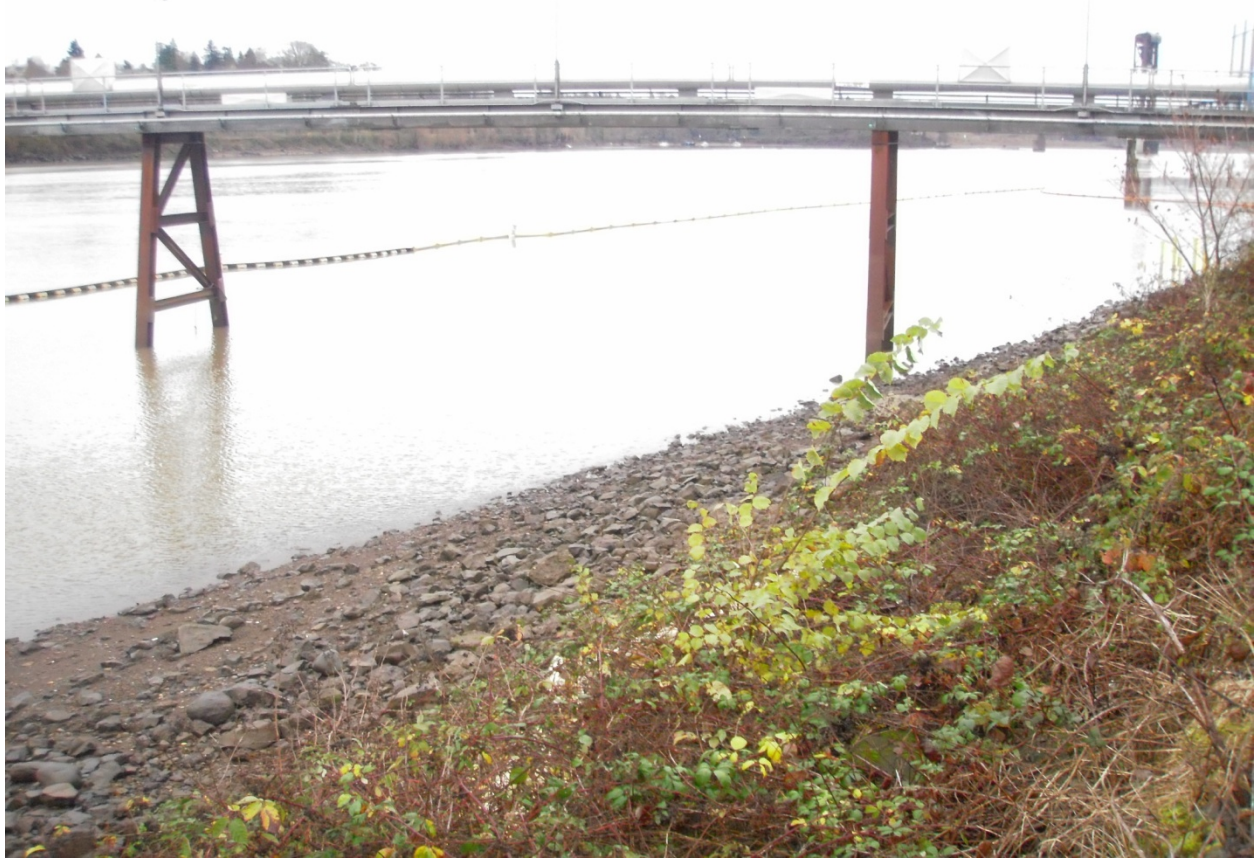
**Other Comments:** No sheen is evident in or around the cap area. Photo 3 shows the water surface and shoreline immediately downriver of the sediment cap.

Photo 3 — *Conditions immediately downriver of cap area (12/26/12):*
